Imaging for Cartilage injuries

Anupama Patil¹, Aniket Jadhav¹

Patil A, Jadhav A. Imaging for Cartilage injuries. *Asian Journal Arthroscopy*. Jan-April 2019;4(1):4-8.

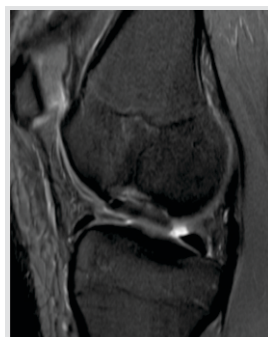
Fig 12: PD fat saturated sagittal image : Stage III osteochondral lesion.

T2 hyperintense cleavage plane causing complete discontinuity of the fragment from the parent bone. The separated osteochondral fragment is however undisplaced. This is an unstable lesion [9]. (Fig. 12)

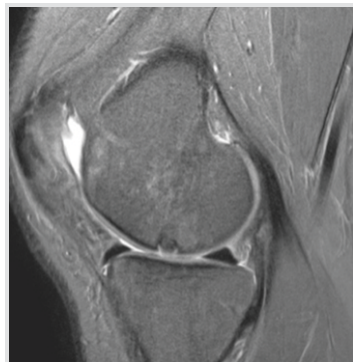
Fig 16: PD fat saturated sagittal image: Normal cartilage repair Osteochondral autograft transplantation surgery (OATS).
